Manhole Inspection Summary

Manhole # S43CC_036MH

Insp Date: **12/18/07 10:09 AM**

Location Address: **1606 ashland ave**

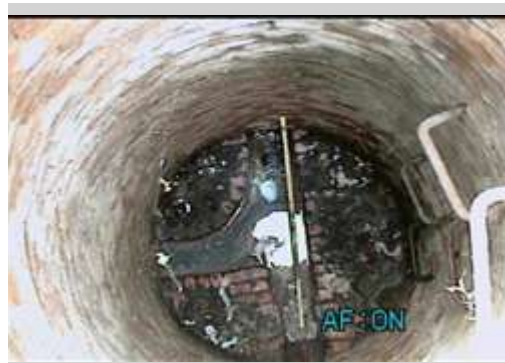
Top View

missing steps

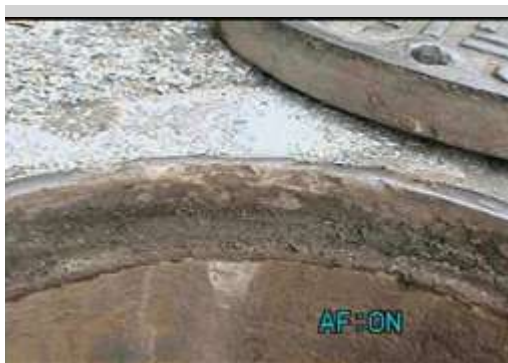
Defect 3

worn frame

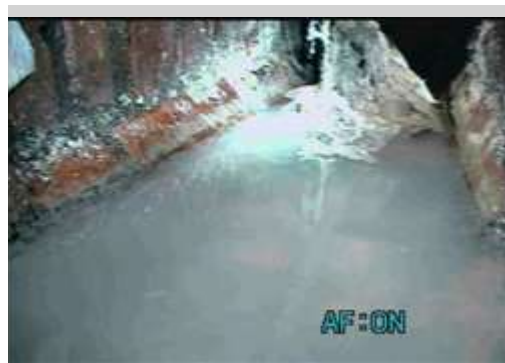
Defect 2

Condition: ☐ Sound ☐ Cracked ☐ Root Intrusion ☐ Deteriorated ☐ Leaks ☒ **Debris**

channel debris

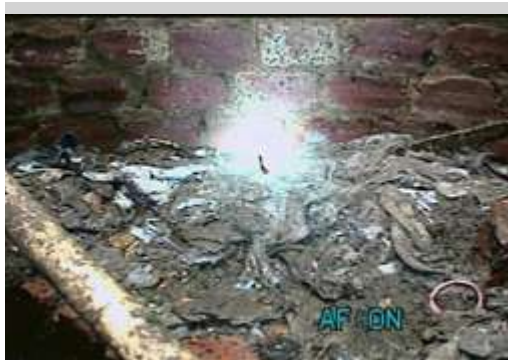
defect 5

Condition: ☐ Sound ☐ Cracked ☐ Root Intrusion ☐ Deteriorated ☐ Leaks ☒ **Debris**

bench debris

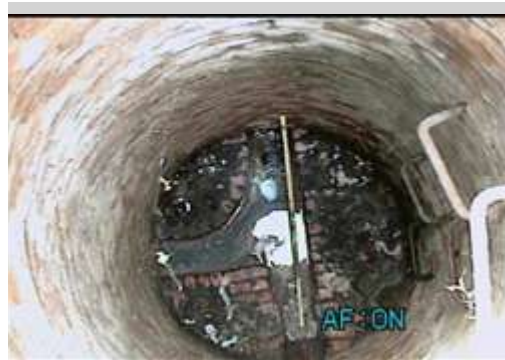
Defect 1

Count: **6** Missing: **1** ☒ **Corroded**

missing steps

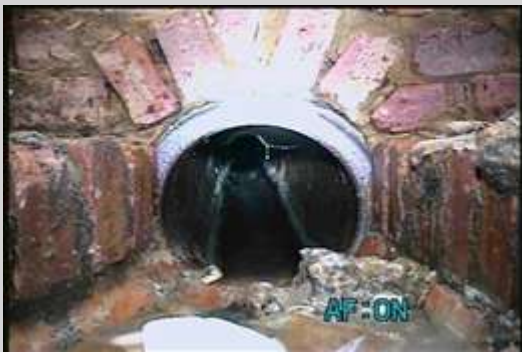
12 O'Clock Outflow

Invert Depth: **10.10** (ft.) Flow Characteristics: **Slow**

Silt Depth: **2** (in.) Deposits Extent: **Medium**

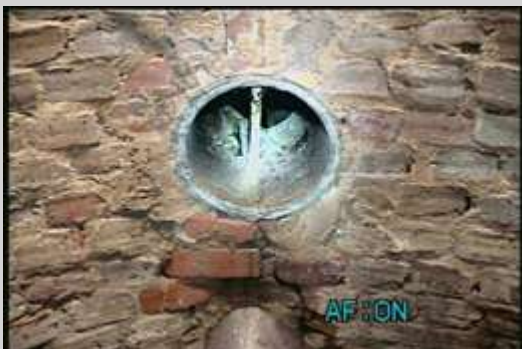
6 O'Clock Inflow

Invert Depth: **9.10** (ft.) Flow Characteristics: **Slow**

Silt Depth: **2** (in.) Deposits Extent: **Medium**

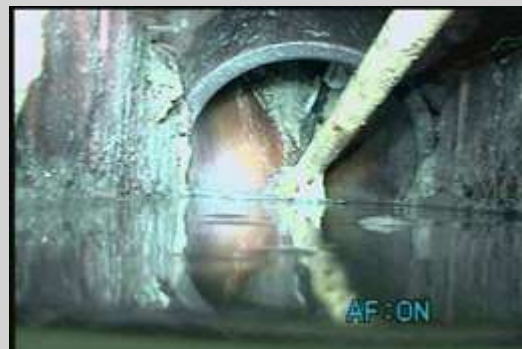
Drop In @ 6 O'Clock

Drop: **Outside Direct**

Drop Condition: **Partly Clogged**

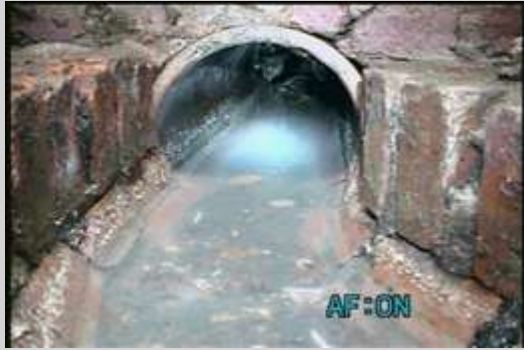
9 O'Clock Inflow

Deposits: ☐ None ☐ Mud ☐ Sludge ☒ Debris ☐ Grease

Silt Depth: 0 (in.) Deposits Extent: Heavy
